NASA STUDENT LAUNCH

2017-2018

POST LAUNCH ASSESSMENT REVIEW (PLAR)

APRIL 27TH, 2018

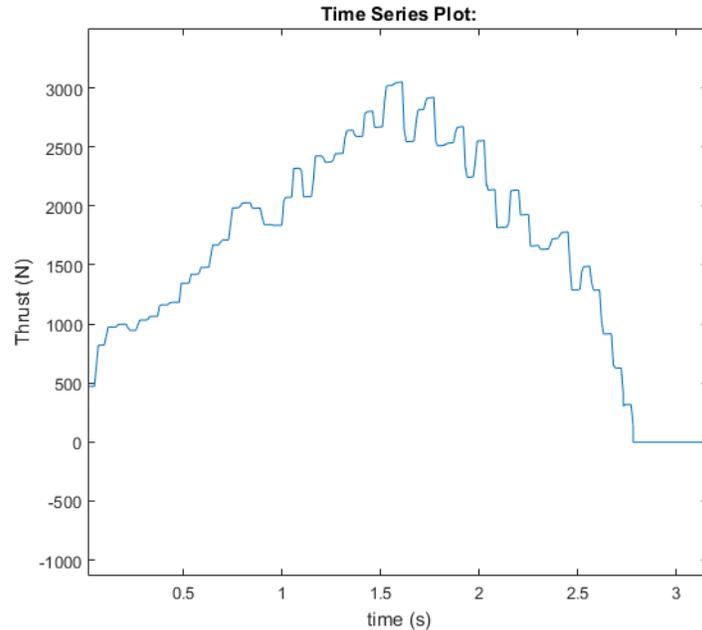
The apogee altitude was approximately 500 ft. lower than anticipated, likely due to a motor anomaly outside of the team's control. To test this hypothesis, the thrust produced by the motor was determined from acceleration data gathered during the flight. A thrust versus time curve from the competition flight is shown below in Figure 4.

Figure 4: Motor thrust produced during competition flight.

Characteristic	Nominal	Recorded	Percent Difference
Maximum Thrust	3,114 N	3050.5 N	-2%
Average Thrust	2,200 N	1,814.5 N	-19%
Total Burn Time	2.32 s	2.78 s	18%
Impulse	5,104 Ns	5,044 Ns	-1%

The above data provides reason to believe that the motor experienced an anomaly prior to igniting on the pad which resulted in an apogee altitude reduction.

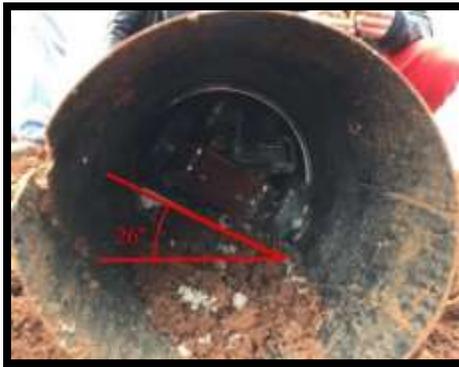
Prior to any interaction with the payload bay, the rover was observed from the open end of the bay from which the rover was intended to exit. The rover was shown to be angled at 26° along the roll axis as shown in Figure 8.

Figure 8: Rover landing orientation.

Based on the tipping analysis described in the CDR document section 5.1.29, this was well within the orientation that would allow the rover to deploy successfully and continue its mission.

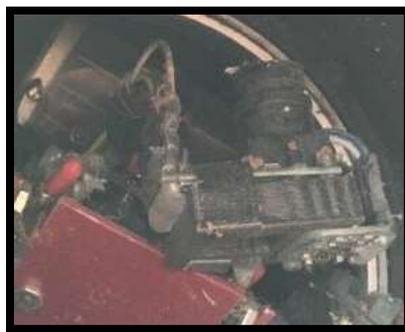
Closer inspection revealed that the servo horn to which the lidar/camera mount was secured had snapped upon impact as shown below in Figure 9.

Figure 9: Broken servo horn.

The rover's controls had a condition to account for damage such that if the system recognized faulty data from the sensor, the Obstacle Avoidance System (OAS) would be ignored for the remainder of the drive phase of the mission. The rover would have been able to complete its mission despite this broken mount.

A more robust servo mount for the lidar/camera module would be implemented to reduce the possibility of the mount failing prior to deployment of the rover.

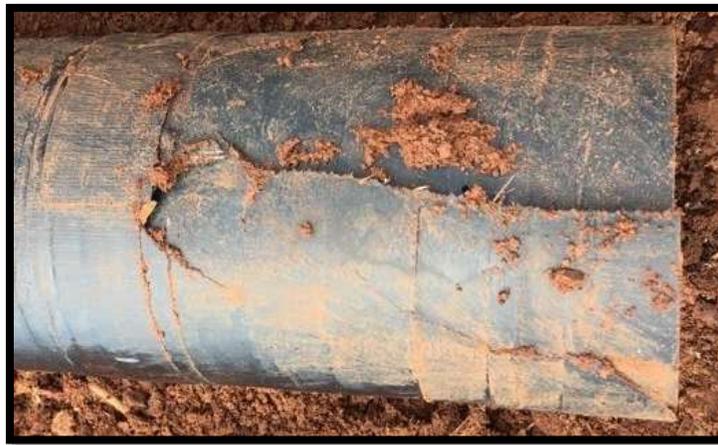
After preliminary visual inspections, the airframe section was rotated and examined for damage. Two large cracks propagated from the open end of the payload bay along the airframe section as shown below in Figure 10.

Figure 10: Payload Bay fracture.

The deformation of the bay caused by this fracture was not significant enough to impact the rover exiting the airframe.

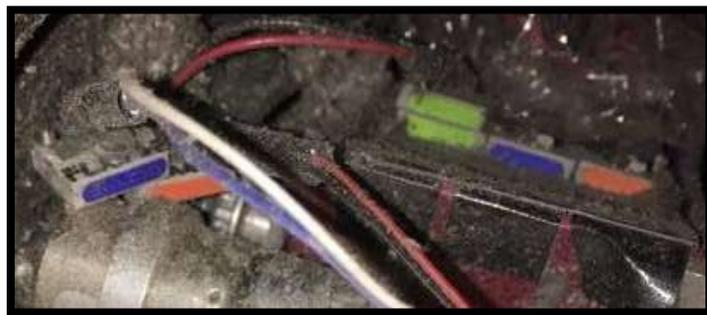
The bay was then taken back to the team prep area and systematically disassembled. The payload recovery bay coupler was removed revealing the disconnected magnetic connectors for the DTS as shown in Figure 11.

Figure 11: Disconnected magnetic connectors.

The orange and blue connectors shown in the image were the DTS power and communication lines respectively. Both sets of connectors disconnected resulting in the deployment signal not being received by the rover CES.

The magnetic connector method would be improved to ensure the connection would not break prematurely. Improvements to the design would include a new method to maintain the connection while still allowing the wires to disconnect, or developing a new method of mitigating the issue of carbon fiber impeding RF transmission and reception that does not require the connectors to disconnect. One such change would be the addition of a plate that would snap into the existing 3D printed motor mount that would prevent large radial displacement of the connectors.

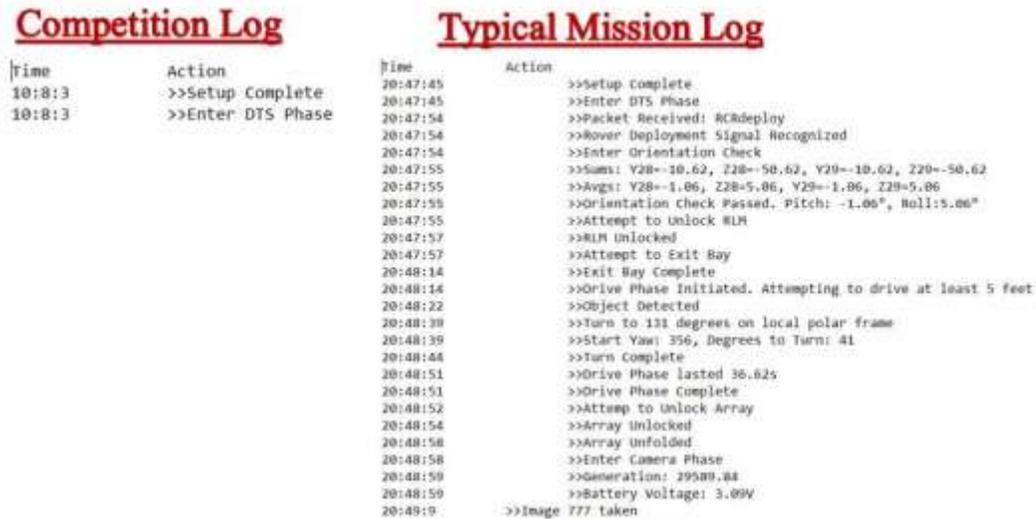
The Control Electronics System (CES) had been configured to log key steps of the mission as they were reached and information about the system such as the orientation of the rover at landing for the orientation check. Viewing this log confirmed that the deployment signal never reached the rover due to the disconnected magnetic connectors. The log for the flight vs a typical mission log is shown below as Figure 12.

Figure 12: Competition log vs typical mission log.

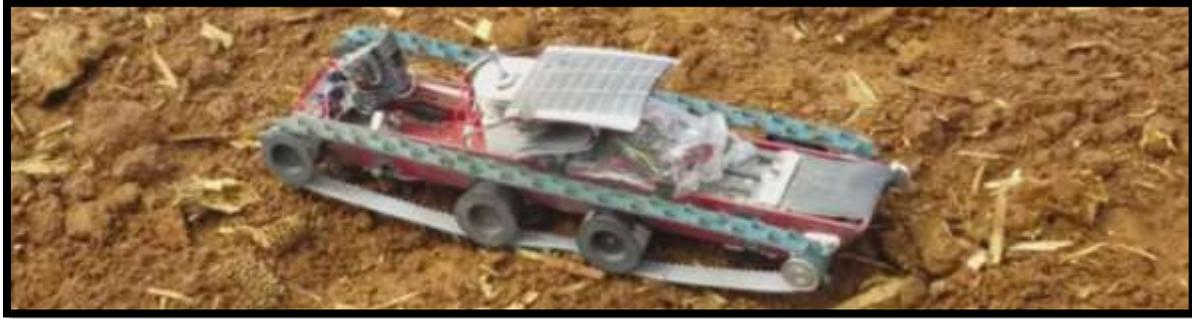
of the passive wheels and corresponding bearings that were used to guide the drive tread dislodged from their housing. The rover is shown traversing the farmland in **Figure 13**.

Figure 13: Rover traversing farmland terrain.

Instead of relying on the press fit of the bearings in their housings, bushings with slip rings would be used to better restrain the wheel shafts. Bushings are also more simple and reliable ball bearings.
