NASA STUDENT LAUNCH

2017-2018

POST LAUNCH ASSESSMENT REVIEW (PLAR)

APRIL 27TH, 2018

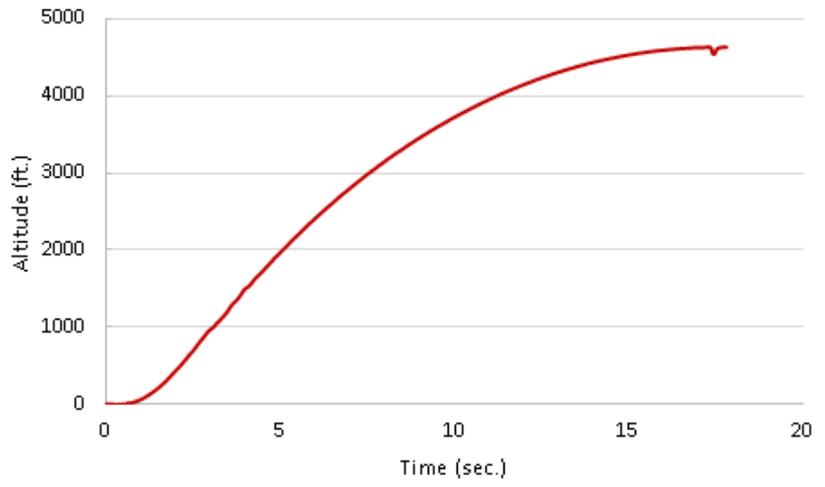
Figure 2: Altitude vs time plot of the competition flight.

Upon ignition of the motor, an unusual smoking occurred for approximately 9 seconds. This smoking of the motor was not observed in any of the previous launches of the vehicle and will be further discussed in 1.2.1. Once the motor fully ignited, the vehicle exited the launch rail stably and ascended to an apogee altitude of 4,646 ft. An altitude versus time plot of the flight is shown below in Figure 2.

Despite the motor anomaly, the ascent of the launch vehicle was nominal. The vehicle flew stably and ascended to apogee with minimal weather cocking and minimal spinning. The recovery of the vehicle occurred nominally apart from an ARRD failure, which deploys the main parachute for the payload section, causing an impact at high velocity. The failure was determined to be caused by pressure venting from the ARRD cylinder through the channel where the e-matches are inserted into the body and is talked about in section 0. The decent speeds are listed and shown below in Figure 3.

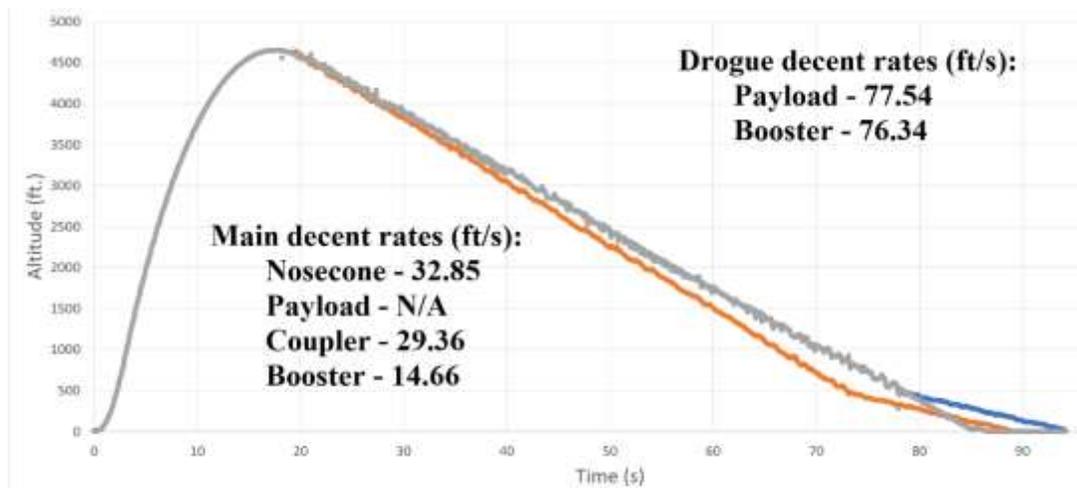
Figure 3: Flight data from StratoLoggers

The competition launch ended with a failure in the payload main's deployment. The failure was determined to be caused by pressure venting from the ARRD cylinder through the channel where the e-matches are inserted into the body. The lack of pressure failed to force the piston upwards and subsequently the drogue was never released to act as a pilot parachute for the main. For all future flights, the e-matches will be inserted into the body of the ARRD and the hole sealed with hot glue and wrapped twice in heavy adhesive tape. This procedure has been added to the safety manual.

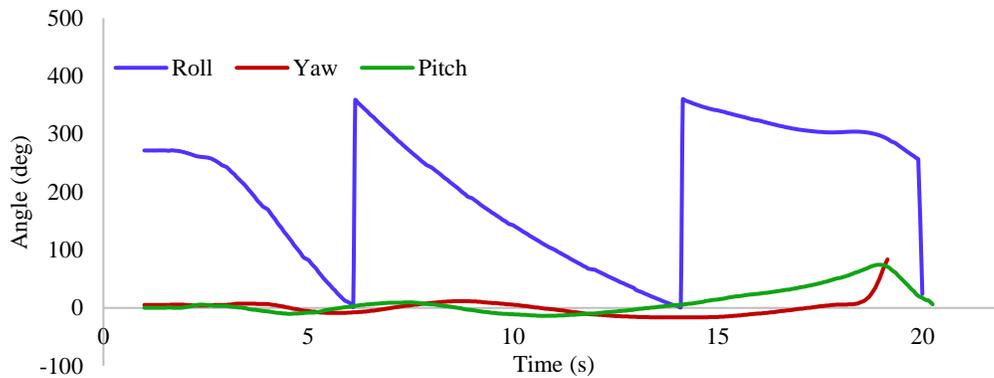
Figure 5: Roll, pitch, and yaw of flight recorded by VDS DAQ system.

The Variable Drag System (VDS) did not utilize its drag blades however its BMP280/BNO055 data acquisition functionality was active during the competition flight and was successfully used for post flight data analysis. The angles of ascent, including the roll, pitch, and yaw of the vehicle as recorded by the BNO55 are shown in Figure 5.

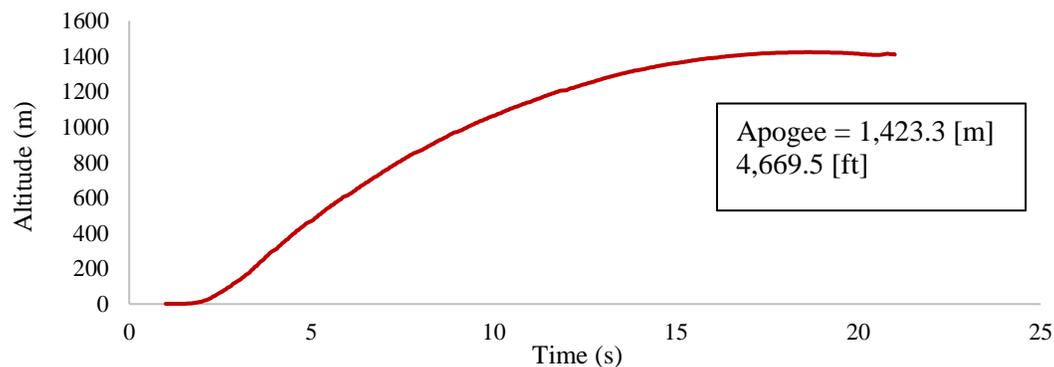
Figure 6: Flight altitude versus time as recorded by VDS DAQ system.

The altitude versus time graph as taken by the BMP280 in the booster section of the vehicle is shown in Figure 6. This sensor recorded an apogee altitude of 4,669.5 ft.

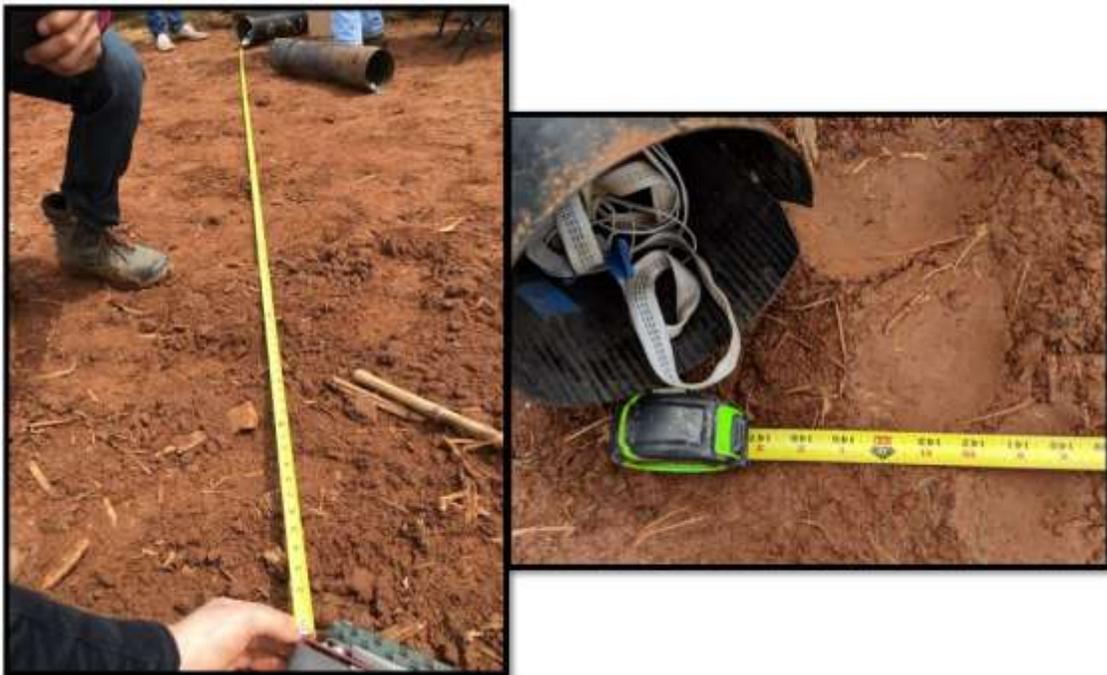
Figure 14: Rover's final distance reached.

The lidar sensor relayed faulty data to the control system as the servo horn could not be repaired prior to this mission test. The system successfully recognized this and ignored the Obstacle Avoidance System. Despite the loss of three passive wheels and the Obstacle Avoidance System, the rover reached a final distance of 12.25 ft. from the airframe as indicated below in Figure 14.
